VOLARE SURVIVAL KIT

Just Say Oh, Oh, Oh

In the mid '80s there were three prime candidates available for an Effie owner interested in dumping his Ford's stock straight-axle suspension in favor of an IFS unit.

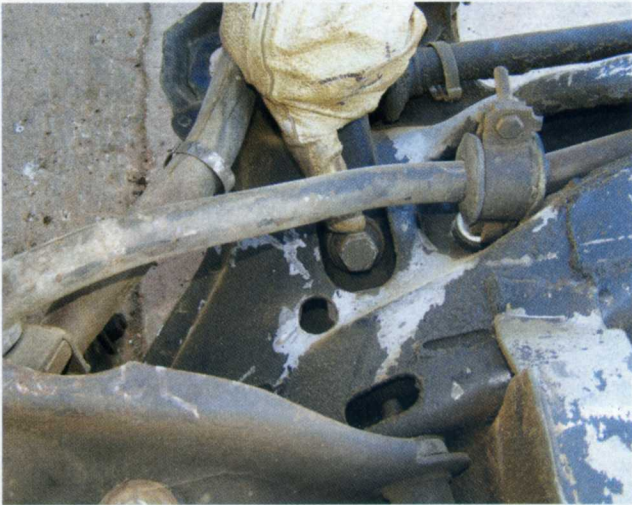
1 Fresh from a clapped-out Chrysler product, this Volare-type frontend needed everything that moves up, down, or steers replaced. No problem—Bob's F-100 Parts has developed and markets a complete rebuild kit.

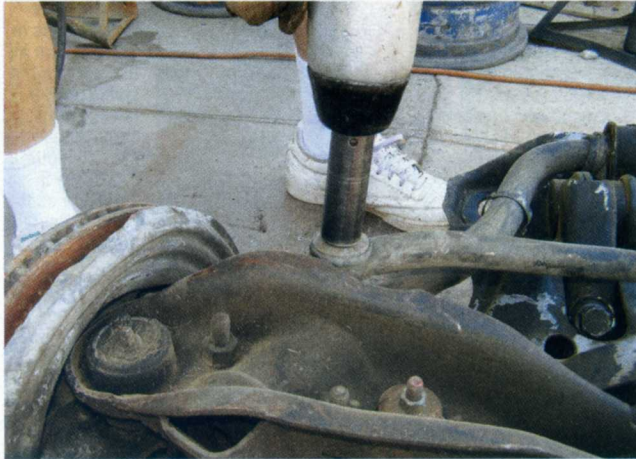
2 The first step Bob took to disassemble the Volare frontend was to back the tension off (unload) of the torsion bars.

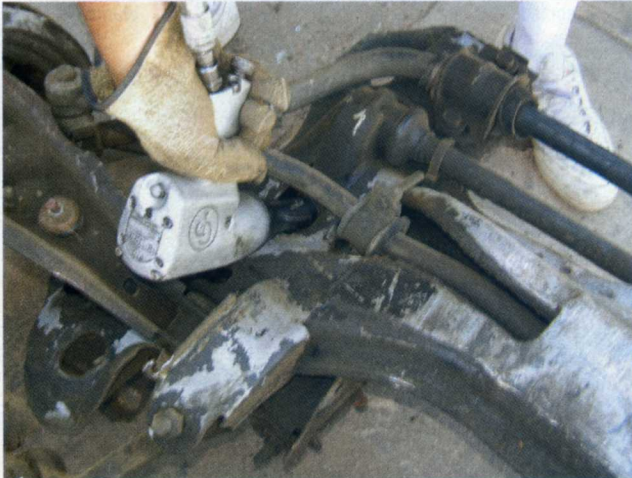
5 Next, the stabilizer bolts and stabilizer hardware at the stabilizer bar ends, including the rubber donuts, were removed. Bob's kit includes all the stabilizer bar hardware that should be replaced, including new rubber donuts.

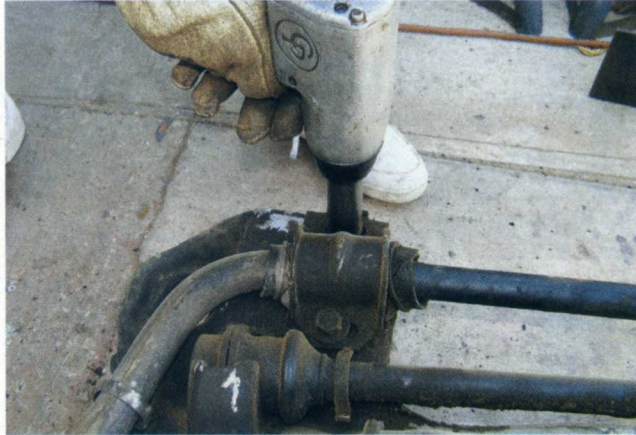
3 It can be done by hand with a ratchet or a breaker bar in a counter-clockwise direction (righthand threads), but Bob used an air impact wrench to make short work of it.

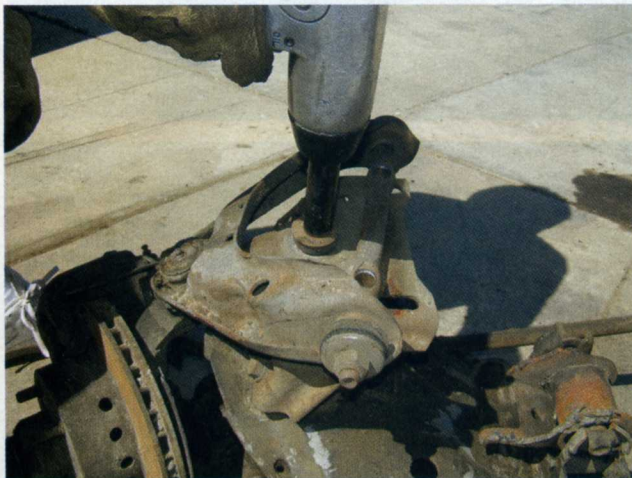
6 Forward of the stabilizer ends are the "clamshells" that attach the stabilizer bar. From the factory these were not replaceable individually, and the complete stabilizer bar assembly is now obsolete. Bob's rebuild kit includes nylon liners that replace the formerly unserviceable part with an upgraded design.

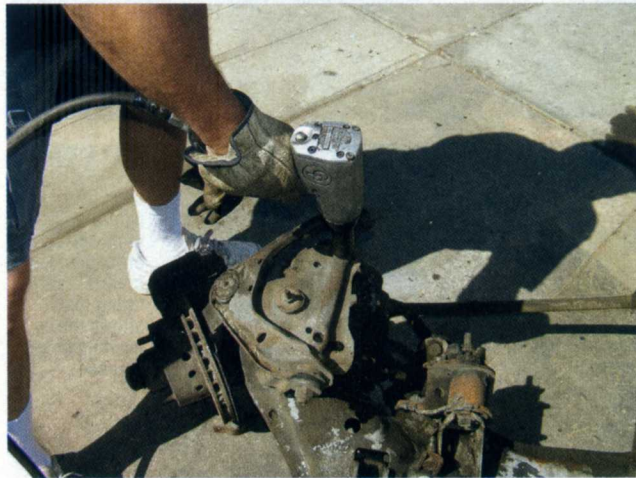
4 Ditto for removing the shock absorbers, which are not included in Bob's Volare suspension rebuild kit, but unless yours are nearly new, they should be replaced.

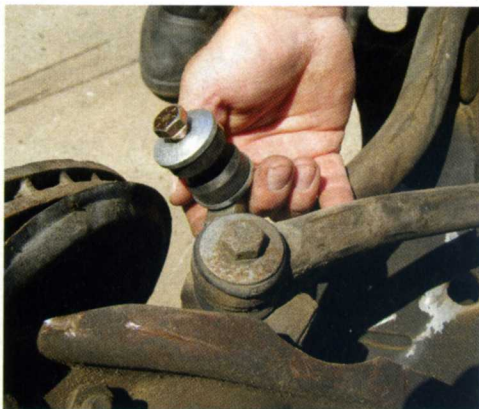
7 The upper control arms were removed by detaching the cross-shaft held by two bolts. After it was removed, Bob visually inspected the cross-shaft for excessive wear or damage.

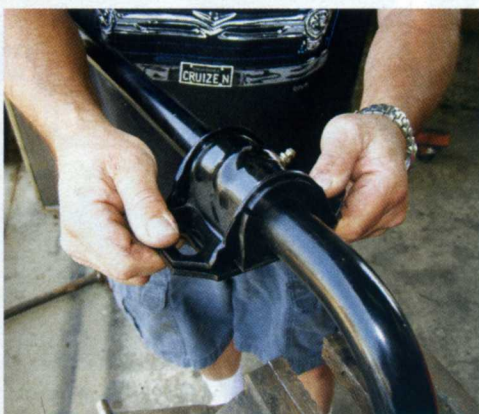
15 The new bushing was spread open and pushed onto the stabilizer bar.

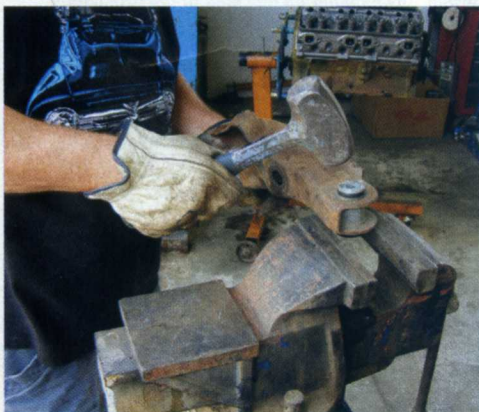
20 Once the ball joints were removed from the lower control arms, the control arms were completely bead-blasted and prepped for the installation of new ball joints and spray-painted black.

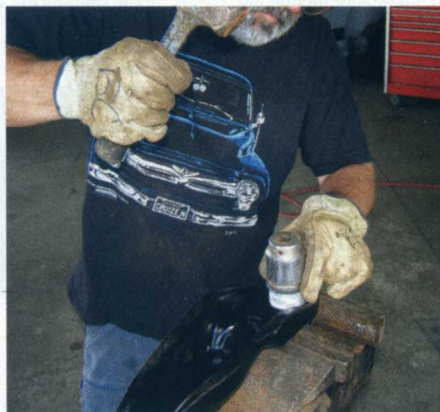
17 A two-pound hammer with a socket used as a drift knocked out the lower control arm bushings.

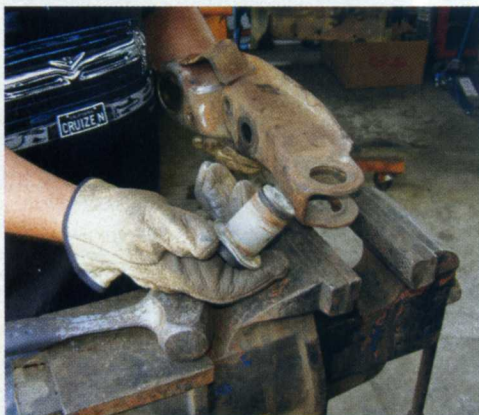
21 Bob securely positioned the lower control arm on the vise and used a large (whatever size will fit snugly over the ball joint) socket driven with a two-pound hammer to install the ball joint into the lower control arm.

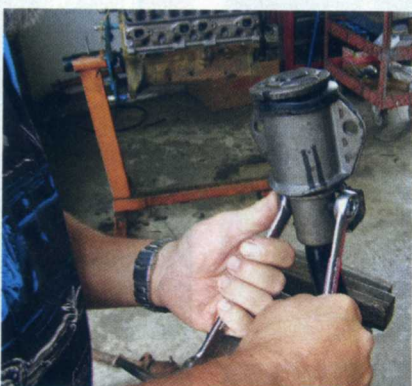
25 With the pin driven out, the torsion bar end was twisted off.
